MERG Report 2000-4

Adit Ice Plug Prevention

By W.D. Mann Consulting

ADIT ICE PLUG PREVENTION

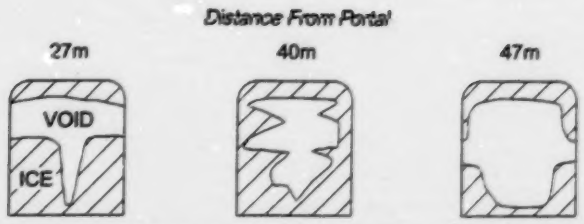
Figure 3. Peerless Adit Cross Sections Showing Ice Distribution
After M.D. Kierans, In: Tindale, 1966

Ice plug dams formed in adits in rock that is slightly below freezing would be expected to drain through tubes within the ice plug. A tube of this type was observed at Mt. Skukum gold mine in July 1997. Cross-sections of a tube through an ice plug were mapped at the Peerless mine, and are presented in Figure 3. A plan and longitudinal section of this mine is presented in Figure 6. Many adits have steel pipes or rails extending out the portal from the mine, which tend to conduct heat and may promote melting.

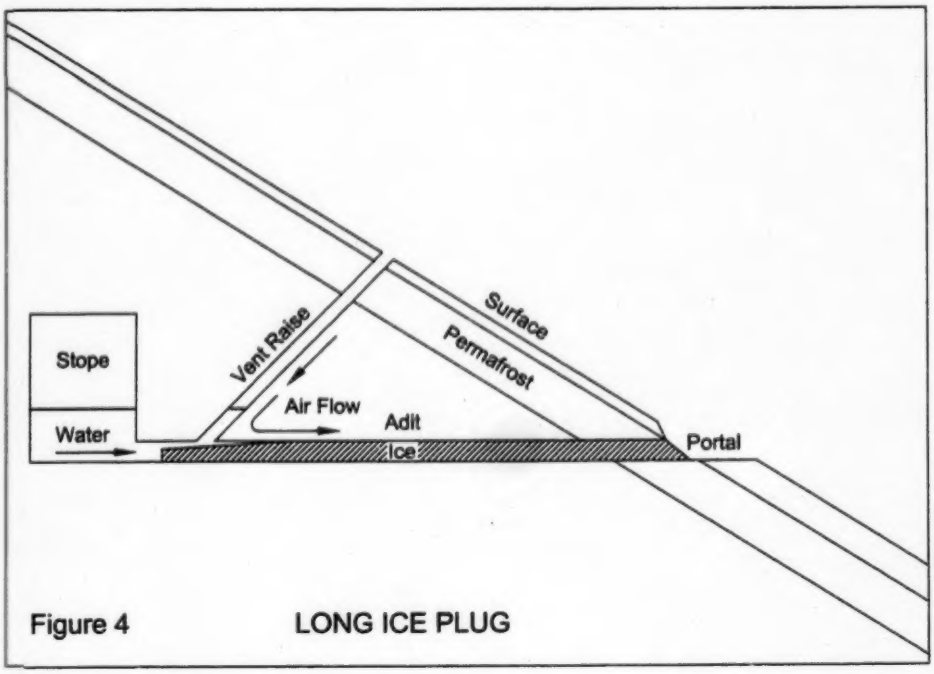
Figure 4 LONG ICE PLUG

Ice plugs 50 to 200 metres in length are documented at the Peerless and Skukum Creek mines. Both of these mines have free air circulation from higher adits, shafts or raises. Figure 4 illustrates a hypothetical mine with a similar configuration with a long ice plug. Ice can form along the length of adit that is exposed to frigid air currents, from the portal to the vent raise. In spring and summer warm air melts the ice back from the portal, and water gradually melts a path through the ice plug from inside the mine. This path widens as water starts to flow, gradually increasing the flow rate until the dammed water is exhausted. The outbursts from the No Cash mine which washed out the Silver Trail Highway were reported to gradually increase in flow over a period of several hours (Hohener, personal communication). The ice plug with a smooth central tube observed at Mt. Skukum gold mine in 1997 is also thought to be of the long type.

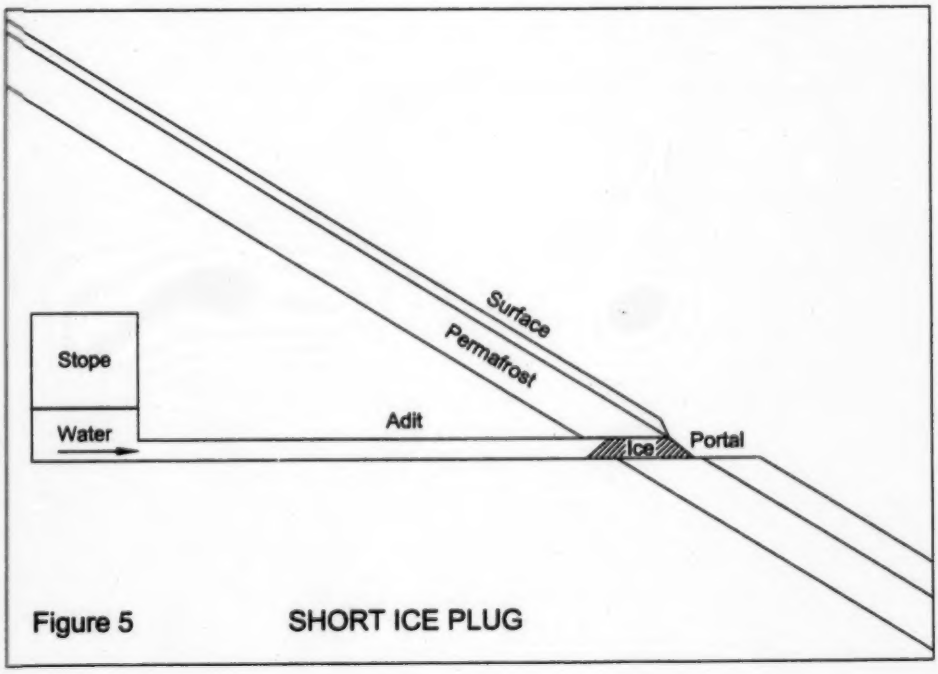
Figure 5 SHORT ICE PLUG

Long ice plugs, up to hundreds of metres long may form when cold air circulates freely through an adit. This type of ice plug fails in a gradual manner, with water flow steadily increasing as the drainage tube through the ice widens. Short ice plugs, about ten metres long occur at portals where there is little circulation of air. A short ice plug can fail rapidly, and the resulting outburst can be catastrophic.
